**Flood Control Project Maintenance
Levee Inspections**

2015 Channel Summary Report

Merced Streams Group

Flood Control Project Maintenance**Unit Cover Sheet****2015 Channel Inspection Results****Merced Streams Group**

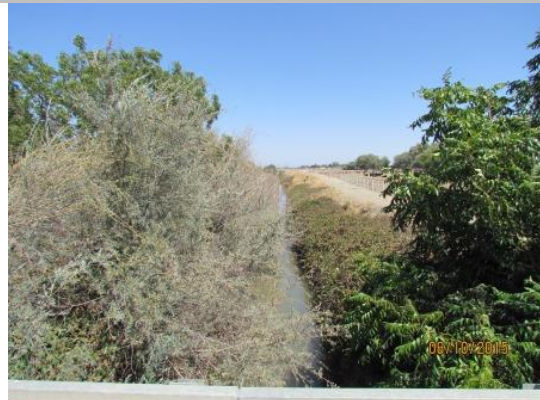
Photo 1 of 1 : CH_2015_NA0013_36_71_20150812_00051.jpg

Inspector Comments: Some woody vegetation in the channel may impede flow. Recommend clearing at least 100 feet upstream.

Upstream view of Miles Creek from Healy Rd. crossing.

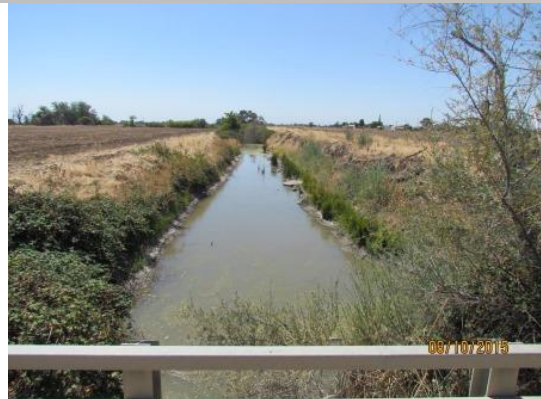
Photo 1 of 1 : CH_2015_NA0013_36_76_20150812_00052.jpg

Check Point / View				
Healy Rd / Down				
Rating **	M	Issue No.	76	GPS Lat/Long
Issue Type +	Ma	Location *		37.263739 °
Category	Rivers, Channels & Designated Flood			-120.434490 °
Item	Vegetation & Obstructions			
DWR ID	DWR_NA0013_36_c _ 2012_76			
Action/Comments				
Inspector Comments: Some woody vegetation in the channel may impede flow. Recommend clearing at least 100 feet downstream.

Downstream view of Miles Creek from Healy Rd. crossing.

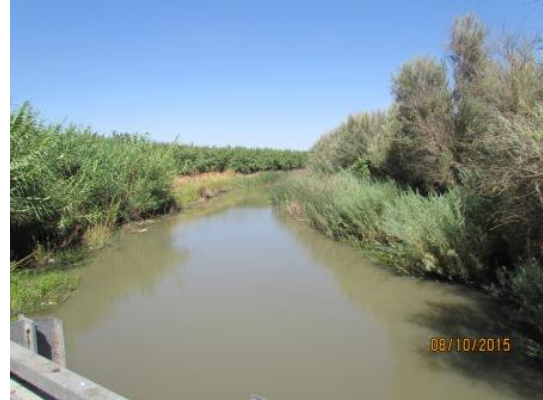
Photo 1 of 1 : CH_2015_NA0013_36_81_20150812_00053.jpg

Rating **	A	Issue No.	81	GPS Lat/Long
Issue Type +	Ma	Location *		37.263658 °
Category	Rivers, Channels & Designated Flood			-120.469774 °
Item	Vegetation & Obstructions			
DWR ID	DWR_NA0013_36_c _ 2012_81			
Action/Comments				
Inspector Comments: Minor vegetation, but does not appear to be enough to impede flow.

Upstream view of Miles Creek from Tyler Rd. crossing.

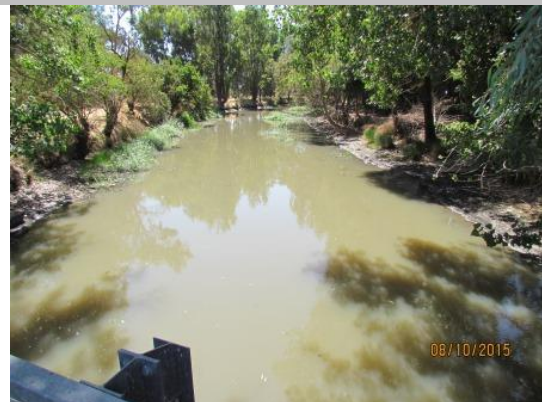
Photo 1 of 1 : CH_2015_NA0013_36_86_20150812_00054.jpg

Inspector Comments: Minor vegetation, but does not appear to be enough to impede flow.

Downstream view of Miles Creek from Tyler Rd. crossing.

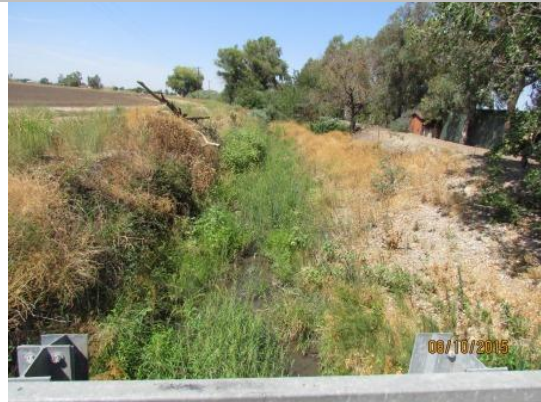
Photo 1 of 1 : CH_2015_NA0013_36_91_20150812_00057.jpg

Rating **	A	Issue No.	91	GPS Lat/Long
Issue Type +	Ma	Location *		37.258252 °
Category	Rivers, Channels & Designated Flood			-120.475232 °
Item	Vegetation & Obstructions			
DWR ID	DWR_NA0013_36_c _ 2012_91			
Action/Comments				
Inspector Comments: Minor vegetation, but does not appear to be enough to impede flow.

Upstream view of Miles Creek from Reilly Rd. crossing.

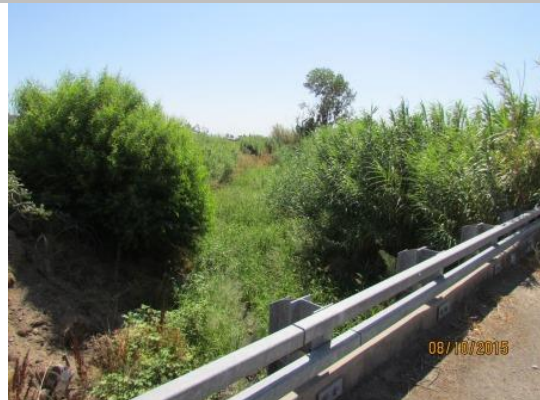
Photo 1 of 1 : CH_2015_NA0013_36_96_20150812_00058.jpg

Check Point / View				
Reilly Rd / Down				
Rating **	M	Issue No.	96	GPS Lat/Long
Issue Type +	Ma	Location *		37.258252
Category	Rivers, Channels & Designated Flood			-120.475230
Item	Vegetation & Obstructions			
DWR ID	DWR_NA0013_36_c _ 2012_96			
Action/Comments				
Inspector Comments: Some woody vegetation which may impede flow.

Downstream view Miles Creek from Reilly Rd. crossing.

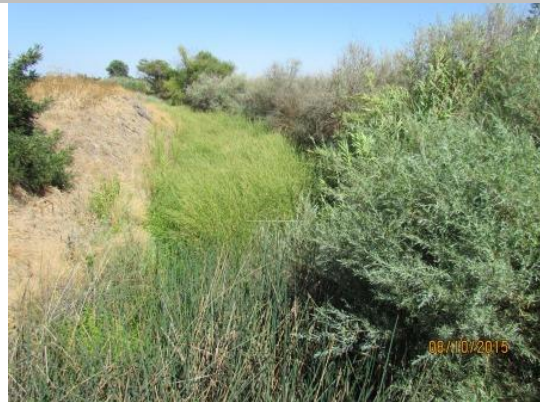
Photo 1 of 1 : CH_2015_NA0013_36_101_20150812_00060.jpg

Inspector Comments: Some woody vegetation which may impede flow.

Upstream view of Miles Creek from Highway 59 crossing.

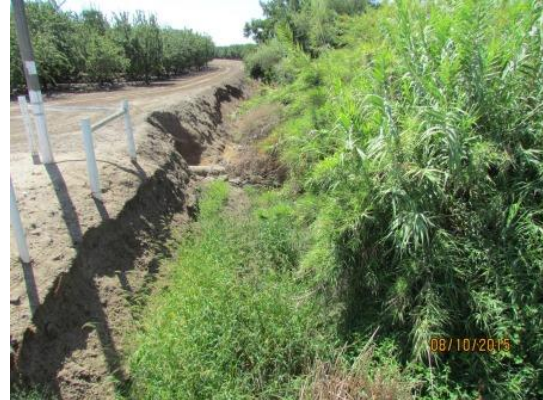
Photo 1 of 1 : CH_2015_NA0013_36_106_20150812_00061.jpg

Rating **	M	Issue No.	106	GPS Lat/Long
Issue Type +	Ma	Location *		37.255886
Category	Rivers, Channels & Designated Flood			-120.487970
Item	Vegetation & Obstructions			
DWR ID	DWR_NA0013_36_c _ 2012_106			
Action/Comments				
Inspector Comments: It appears that the Black walnut tree has been removed at the bridge. However there is more woody vegetation growing downstream in the channel, this can impede flow, please remove.

Downstream view of Miles Creek from Highway 59 crossing.

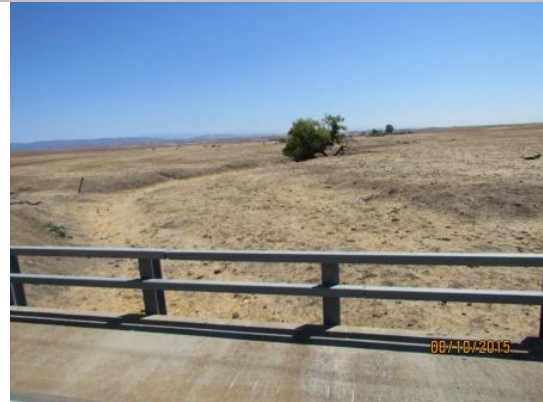
Photo 1 of 1 : CH_2015_NA0013_37_1_20150812_00015.jpg

Inspector Comments: No vegetation within channel noted.

Upstream view from Cunningham Road crossing.

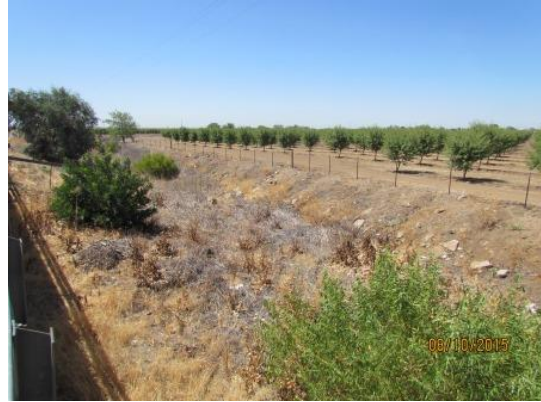
Photo 1 of 1 : CH_2015_NA0013_37_6_20150812_00016.jpg

Rating **	A	Issue No.	6	GPS Lat/Long
Issue Type +	Ma	Location *		37.290387 °
Category	Rivers, Channels & Designated Flood			-120.251840 °
Item	Vegetation & Obstructions			
DWR ID	DWR_NA0013_37_c _ 2012_6			
Action/Comments				
Inspector Comments: Vegetation is present, but not enough to impede flow during high water events.

Cunningham crossing downstream view.

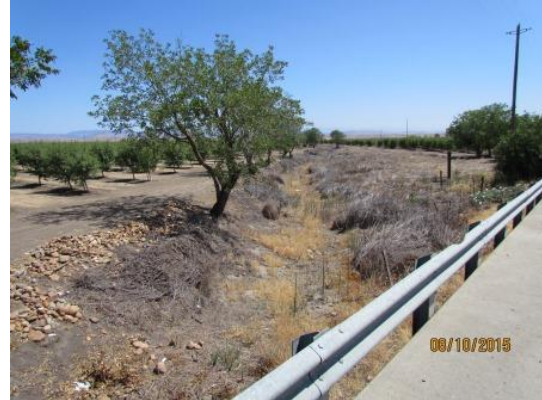
Photo 1 of 1 : CH_2015_NA0013_37_11_20150812_00017.jpg

Inspector Comments: Some vegetation, but does not appear to be enough to impede flows.

Upstream view of Childs Ave. crossing.

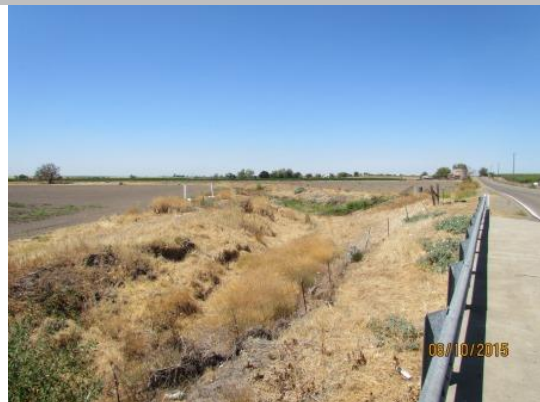
Photo 1 of 1 : CH_2015_NA0013_37_16_20150812_00018.jpg

Inspector Comments: Some minor vegetation present, but will not impede flows.

View of downstream channel at Childs Ave.

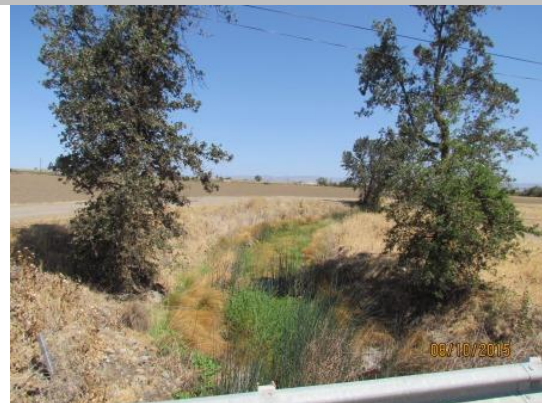
Photo 1 of 1 : CH_2015_NA0013_37_21_20150812_00019.jpg

Inspector Comments: Minor vegetation but does not appear to be enough to impede flow.

Upstream view of Owens Creek from Mission Ave. crossing.

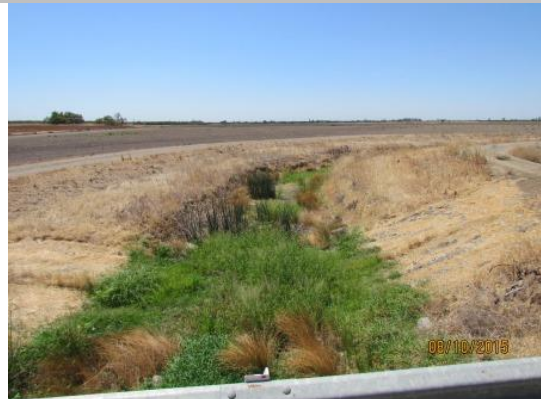
Photo 1 of 1 : CH_2015_NA0013_37_26_20150812_00020.jpg

Inspector Comments: Minor downstream vegetation, but does not appear to be enough to impede flow.

Downstream view of Owens Creek from Mission Ave. crossing.

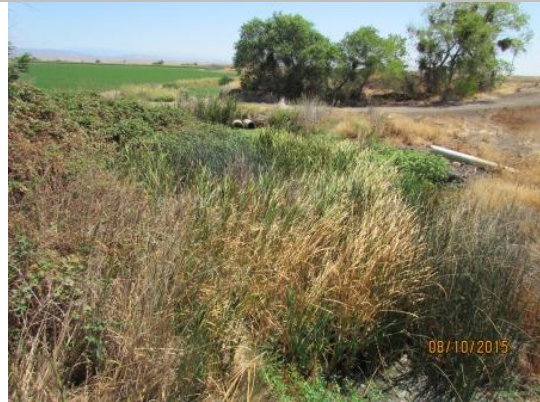
Photo 1 of 1 : CH_2015_NA0013_37_31_20150812_00021.jpg

Rating **	M	Issue No.	31	GPS Lat/Long
Issue Type +	Ma	Location *		37.273393 °
Category	Rivers, Channels & Designated Flood			-120.277410 °
Item	Vegetation & Obstructions			
DWR ID	DWR_NA0013_37_c _ 2012_31			
Action/Comments				
Inspector Comments: Vegetation is thick and obstructing flow.

Upstream view of Owens Creek at diversion.

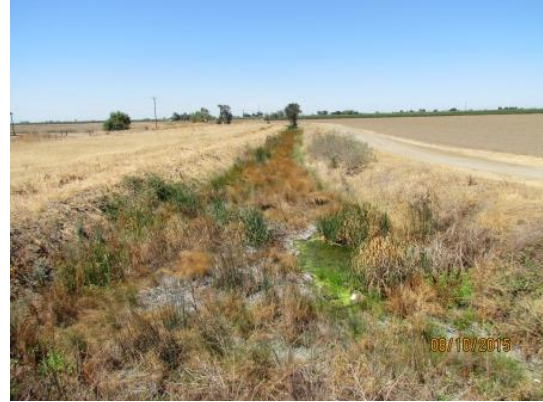
Photo 1 of 1 : CH_2015_NA0013_37_36_20150812_00022.jpg

Rating **	A	Issue No.	36	GPS Lat/Long
Issue Type +	Ma	Location *		37.273393 °
Category	Rivers, Channels & Designated Flood			-120.277410 °
Item	Vegetation & Obstructions			
DWR ID	DWR_NA0013_37_c _ 2012_36			
Action/Comments				
Inspector Comments: Vegetation is noted but not enough to impede flows.

Downstream view of Owens Creek from the diversion.
